SUMMARY OF THE NCHRP REPORT 350  
CRASH TEST RESULTS FOR THE  
CONNECTICUT IMPACT ATTENUATION SYSTEM (CIAS)

December 2004

2216-3-03-6

Connecticut Department of Transportation  
Bureau of Engineering and Highway Operations  
Office of Research and Materials

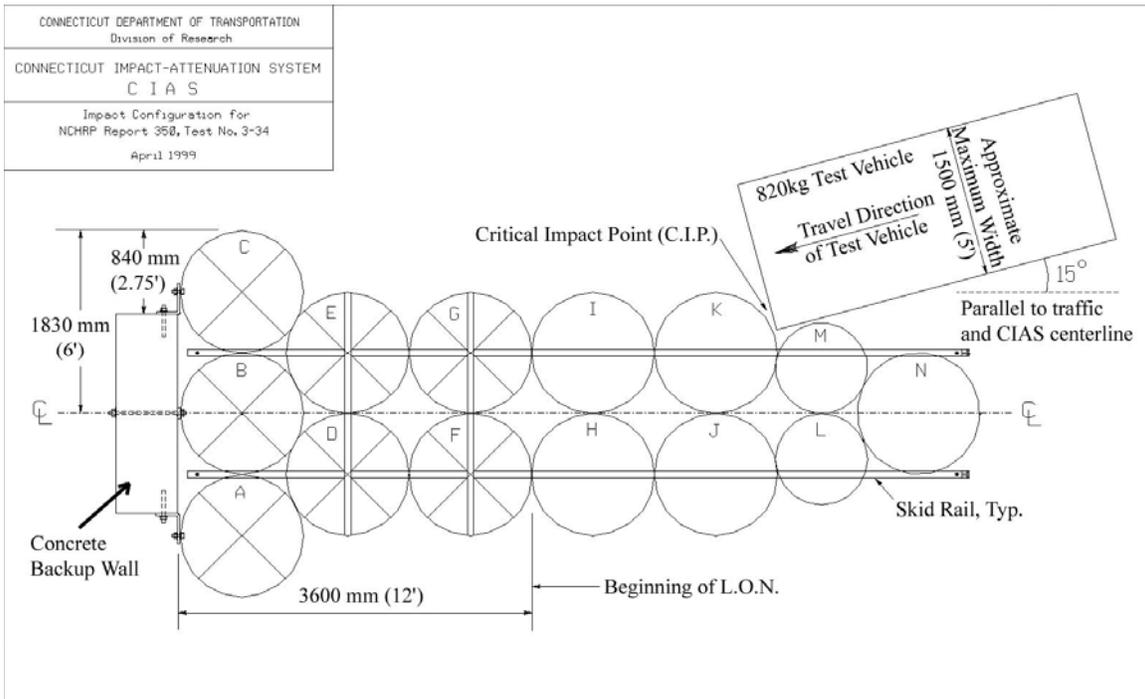
**Figure 3. Impact Configuration for Test Designation 3-34**

impact point (CIP) at a speed of 100 km/h (62 mph) and an angle of 15 degrees. The CIP is a point along the longitudinal dimension of the crash cushions between the beginning of the system and before the length of need (LON) that when hit has the greatest potential for causing a failure of the test. Failure of the test under the recommended criteria would include excessive wheel snag, pocketing or structural failure of the system. The LON is defined as the part of the longitudinal barrier or terminal designed to contain and redirect an errant vehicle. The impact configuration for this test is shown in Figure 3.

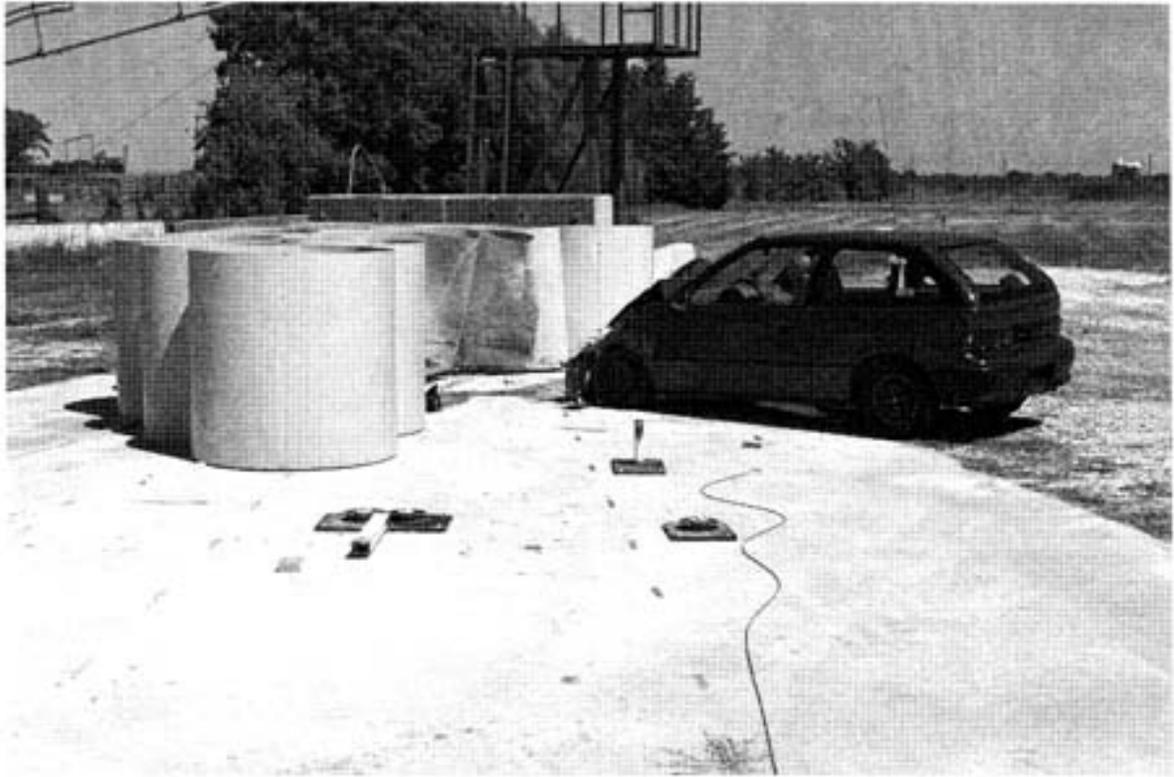
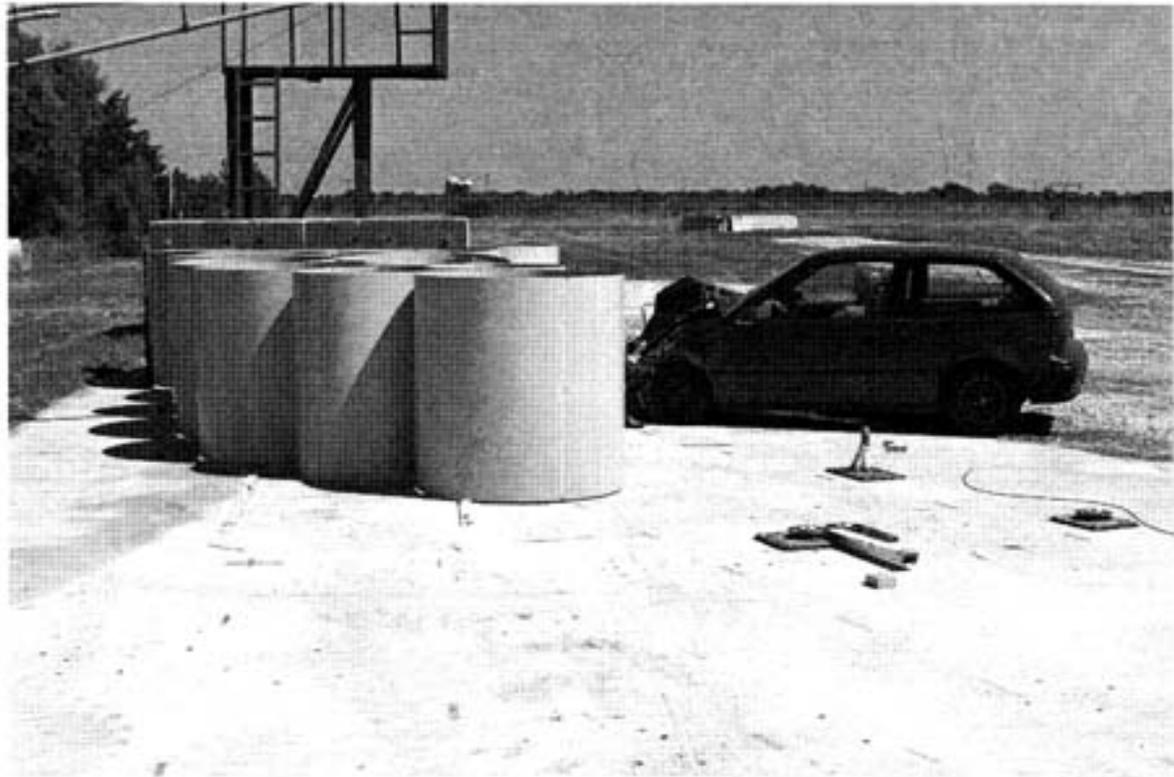
Figure B3-4 Installation After Test 3-34

vehicle lost contact with the CIAS and began traveling backwards for about 1.5 seconds before it came to rest at barrel G. Cylinders A, K, I and G were the most deformed, E and F were slightly deformed, and the remaining cylinders had little or no noticeable deformations.

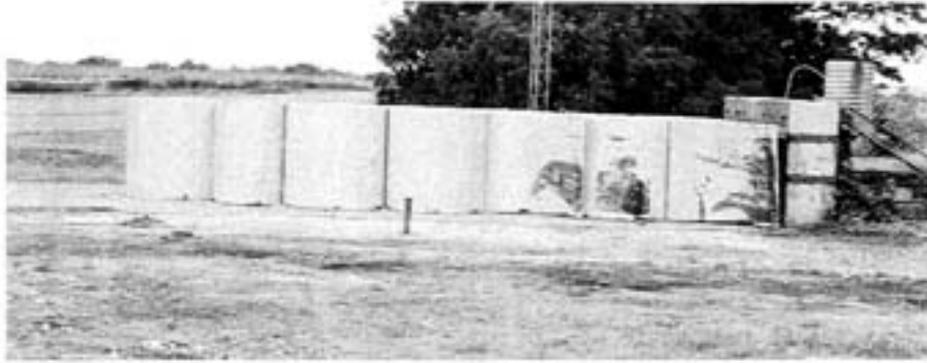
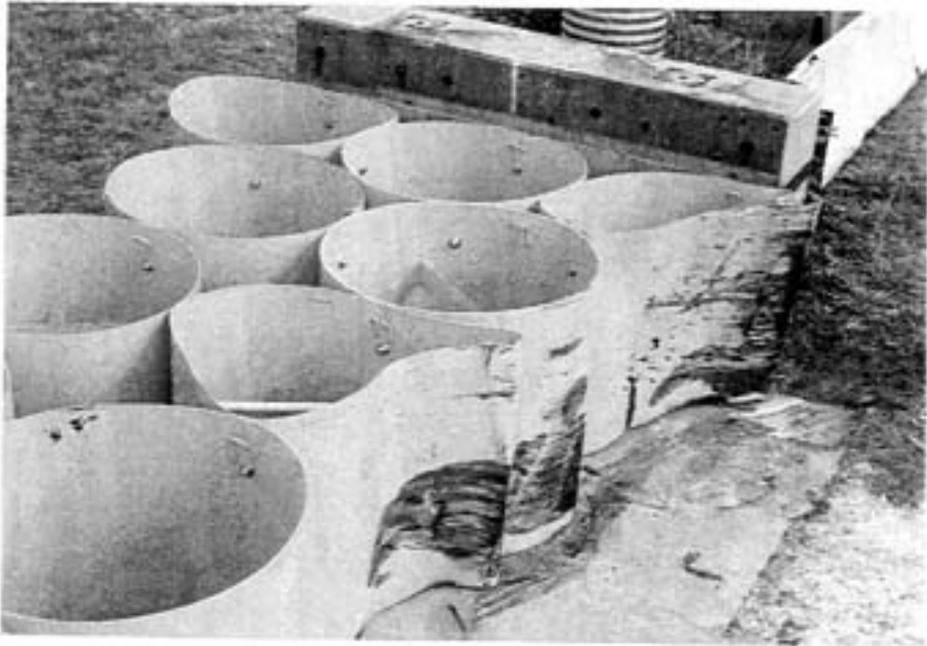
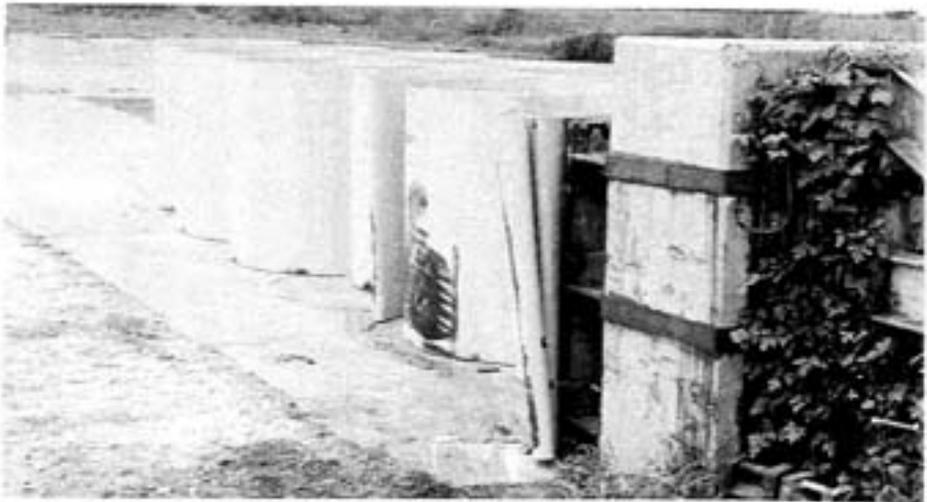
Figure B5-5 Installation After Test 3-38

The results for test 3-38 are that the vehicle was traveling at 100.71 km/h (62 mph), and impact with the CIAS was at 19.94 degrees. After striking the attenuator, the vehicle was redirected, but not enough to prevent the left front end from snagging the rigid backup wall. The vehicle then came to rest 15 m (49.2 ft) down from the CIAS. As a result of the snagging, it was determined that the exit angle

(38.39 degrees) was greater than the allowable of 60% of the impact angle, and the damage that occurred to the occupant compartment was significant enough to deem the test unacceptable.

As a result of this test, the backup wall was modified to reduce the overall width of 2.7 m (9 ft) down to 2.0 m (6.5 ft). Subsequently, it was determined that test 3-35 would be required and would supersede the results of test 3-38.
