Alternative Merge Sign at Signalized Intersections

Report No.  
CT-2233-F-05-4

Research Project: SPR-2233

Connecticut Department of Transportation  
Bureau of Engineering and Highway Operations  
Division of Research

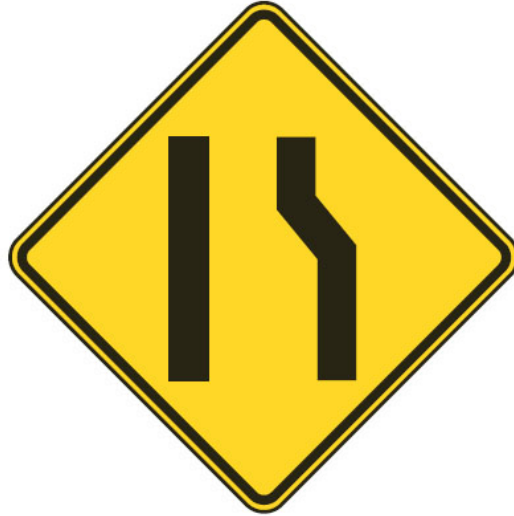
Figure 1 W4-2, "Lane Ends", MUTCD 2000, Millennium Edition

Warning signs alert road users to conditions that might call for a reduction of speed or an action in the interest of safety and efficient traffic operations [1]. One condition that drivers should be made aware of is when a lane is about to end. This requires drivers to merge, which is defined in the Merriam-Webster's Collegiate Dictionary as "to blend or come together without abrupt change" [2]. At the present time, the "Lane Ends" Sign (Federal Sign No. W4-2), as depicted in Figure 1, is being used in Connecticut and many other states to alert drivers when an additional through-lane is ending after a signalized intersection.

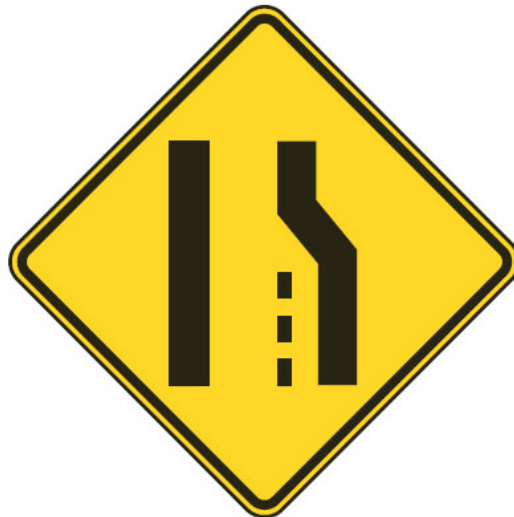
Figure 4 W4-2 Sign, Modified,  
MUTCD 2003 Edition

During the term of this "Alternative Merge Sign at Signalized Intersections" research project, the new MUTCD 2003 Edition [8] was published and the W4-2 sign was modified. The intent is to help motorists better understand the sign, as shown in Figure 4 below. The new design sign must be within 10 years from the effective date of the Final Rule for the 2003 MUTCD, therefore the compliance date is December 22, 2013.

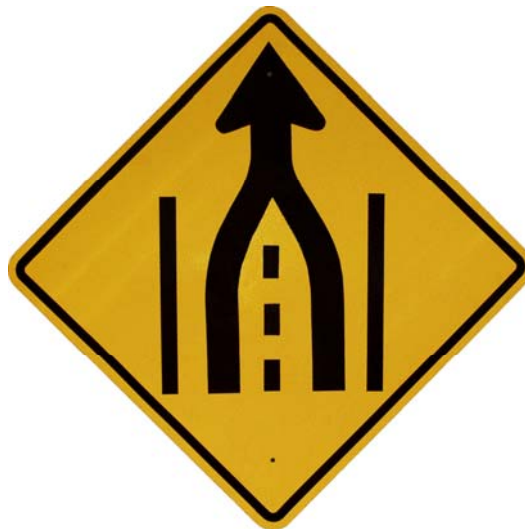
Figure 5 2-500(Ex) Experimental Merge Sign

Following the two surveys, sign "C" (see Figure 5) was chosen as the proposed experimental sign based on engineering judgment and survey results. This sign was designed to represent the Merriam-Webster definition of merge mentioned earlier.

There are two main parts of the sign: the arrow and the roadway display. The arrow, which warns to merge ahead, was designed to encourage an alternating merge pattern; with no one having the right-of-way. The display of the roadway shows two lanes going into one lane, but does not indicate what the roadway geometry is ahead. This was

done purposely so the sign can be used with any lane reduction scenario (left or right lane ending, or road narrows). After the determination of the trial sign, a request for permission to experiment, according to Section 1A.10, "Interpretations, Experimentations, and Changes", of the MUTCD 2000, Millennium Edition, was initiated and submitted to the Federal Highway Administration (FHWA), Office of Transportation Operations. The complete application is in Appendix A, page A-9. After review of the request for experimentation of alternative merge symbol signs at signalized intersections, the proposed sign was approved and assigned an official experimentation number and title as 2-500(Ex) - "Alternative Merge Symbol Signs at Signalized Intersections-CTDOT". Refer to Appendix A, page A-14 for the acceptance letter.

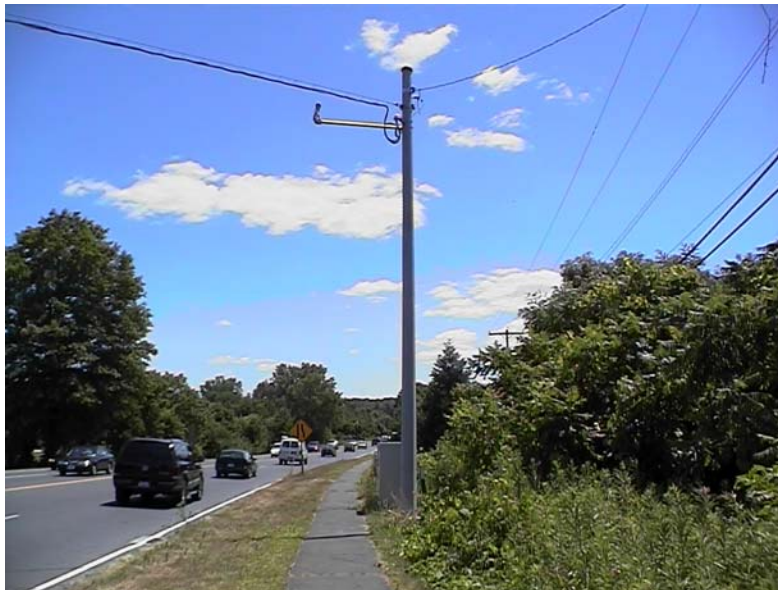
Photograph 1 Route 4, Eastbound, Farmington, CT

At the Farmington site, the camera was installed by a contractor. A sign pattern was provided by a Connecticut Department of Transportation maintenance crew to protect the workers but a lane closure was not necessary. The camera was attached to a 6-foot pole that was attached to the span pole on the eastbound side of the roadway. The camera's wire connection was then pulled through an existing conduit to the traffic cabinet used for the intersection. The cabinet housed the data acquisition system and digital video recorder. A small video monitor was utilized during the time of installation to view real time video in order to adjust the camera to optimize recording of merges.

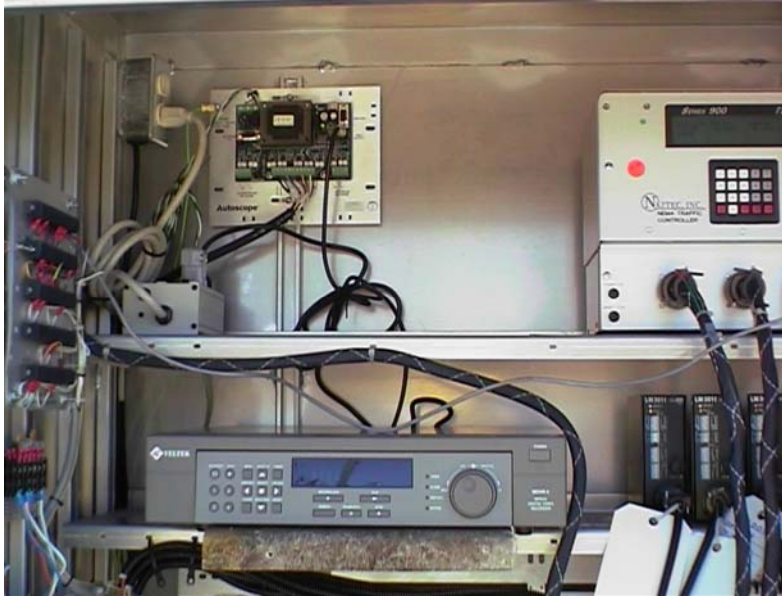
Photograph 2 Traffic Cabinet with Data Acquisition System and DVR

The purpose of the field study phase was to compare traffic behavior with the existing (W4-2) and the experimental [2-500(Ex)] signs in place. In order to monitor this behavior, cameras were installed at both locations. Traffic-monitoring cameras with speed detection and volume counting capabilities were chosen to monitor each merge location. The video from each camera was captured by a stand-alone digital video recorder (DVR) onto 80-gigabyte hot-swappable hard drives. The hard drives were capable of saving approximately 24 hours of video at 30 frames-per-second. The hard drives were routinely exchanged with another hard drive so the video could be reviewed in the office on another digital video recorder.

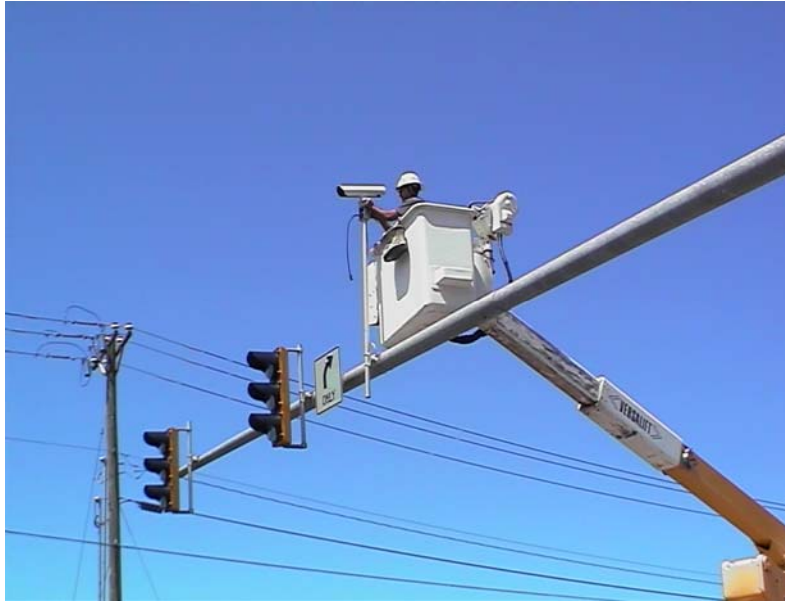
Photograph 3 Camera Installation, Route 229, Southbound, Southington, CT

At the second site in Southington, the camera was also installed by a contractor. A sign pattern was provided by a ConnDOT maintenance crew for a necessary lane closure. The camera was attached to a 6-foot pole and then attached to the mast arm above the intersection. The camera was pointed in the southbound direction and adjusted using the same procedure as the Farmington site. The camera's wire connection and housing of the data acquisition system and digital video recorder were identical to the Farmington site.

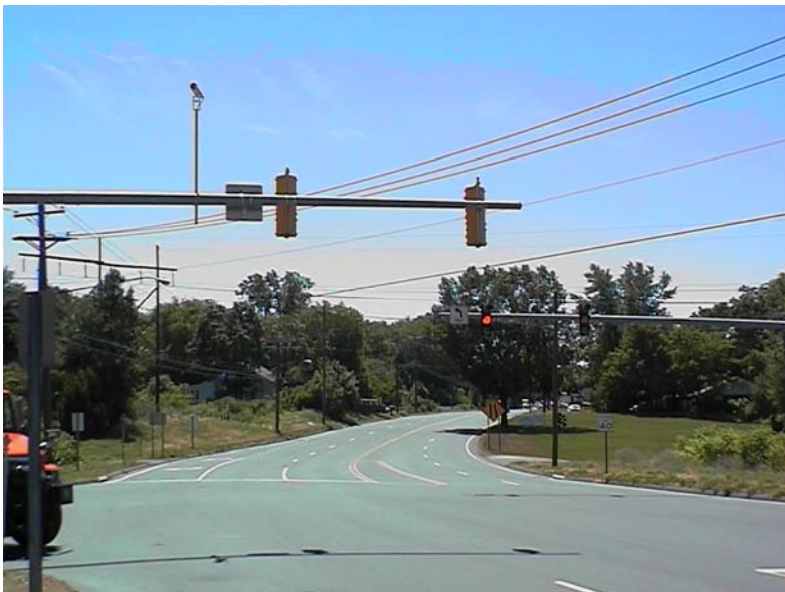
Photograph 4 Route 229, Southbound, Southington, CT

After installation and adjustment of the cameras at each location, the cameras needed to be calibrated for their traffic-counting and speed-detection capabilities. A vendor representative for the cameras assisted in the calibration of these camera systems. A

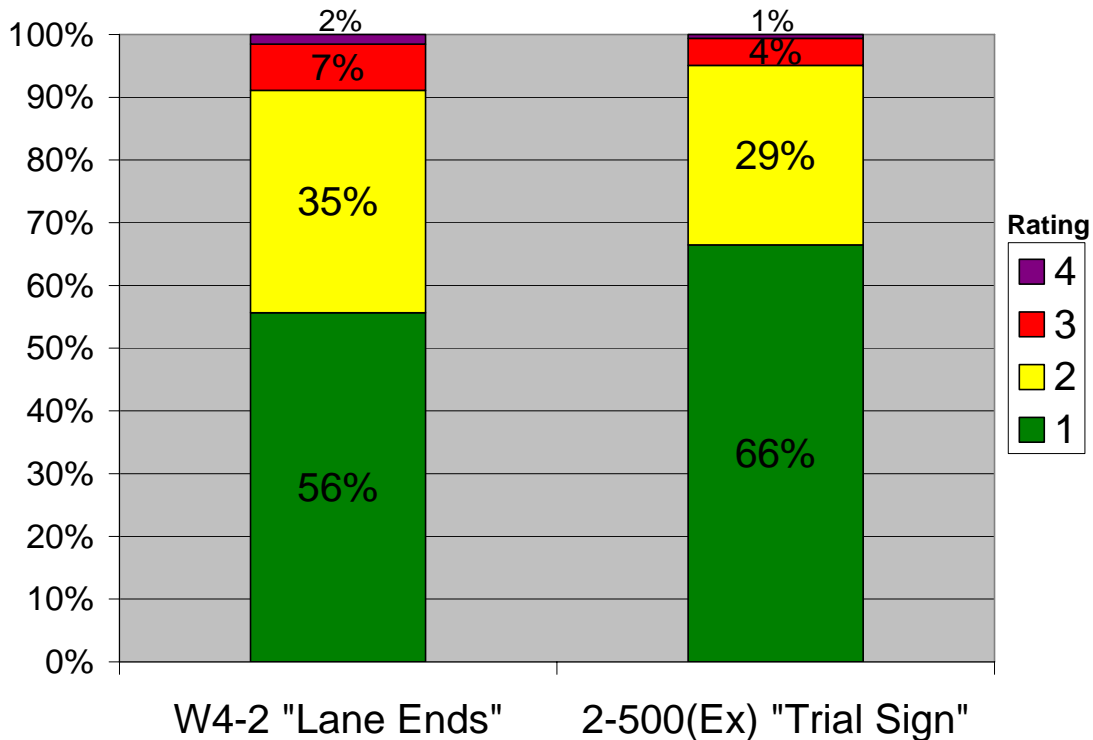
Figure 8 Rating Number Distributions for Merging Events  
(Rating: 1 Best to 4 Worst)

Since the evaluators were found to be consistent, the three research engineers were not considered a variable in the rating procedure. Following this analysis, the data recorded for each sign at each location were examined. The old and experimental signs were compared at both locations, combined, and at each location individually. To begin, the rating number distribution for merging events was investigated with both locations, combined. Figure 8 demonstrates that the experimental sign had an increase from 56 percent to 66 percent for very desirable merges (rating of 1) and a 4 percent reduction in undesirable merges (ratings of 3 & 4).
