1 **EVALUATION OF THE RECTANGULAR RAPID FLASH BEACON AT A PINELLAS**  
2 **TRAIL CROSSING IN ST. PETERSBURG, FLORIDA**

3  
4 **Paper # 12 -1637**

34  
35  
36  
37  
38  
39 **For Presentation at the 2012 Annual Meeting of the Transportation Research Board and**  
40 **Publication in the Transportation Research Record**

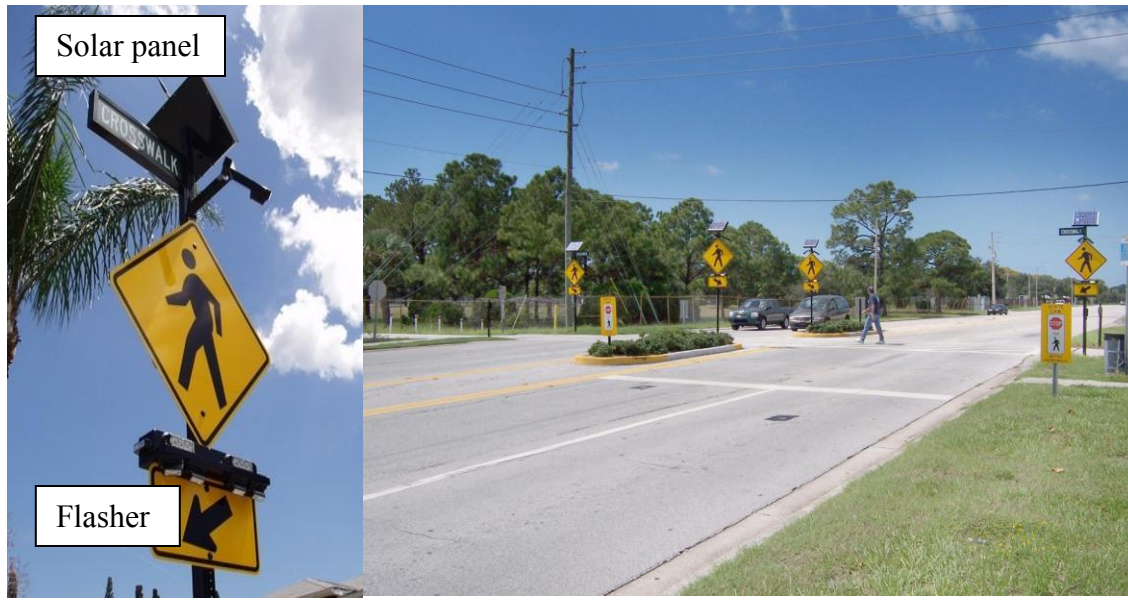
25  
26 Figure 1 shows a close-up view of a single RRFB beacon and the system installed at the  
27 trail crossing. Four rectangular yellow LED indicators which flash rapidly on both front  
28 and back in a wig-wag sequence (left and then right) were installed, one at the edge of the  
29 street on each approach and two more indicators in the median. These face approaching  
30 motorists and indicate that a trail user is present and that motorists should stop or yield.  
31 The wig-wag sequence produces a "stutter-flash effect" similar to some emergency  
32 vehicles. The unit is solar-powered and uses radio frequency transmitters to link the  
33 devices so a depression of any of the call buttons activates the flashers on all signs. A  
34 separate LED faces the pedestrian and flashes to indicate the system is operating. An  
35 audible message instructs users to wait for motor vehicles to stop before crossing.

2 **FIGURE 1 RRFB close-up and system installation at the Pinellas Trail crossing and**  
3 **22<sup>nd</sup> Avenue N.**

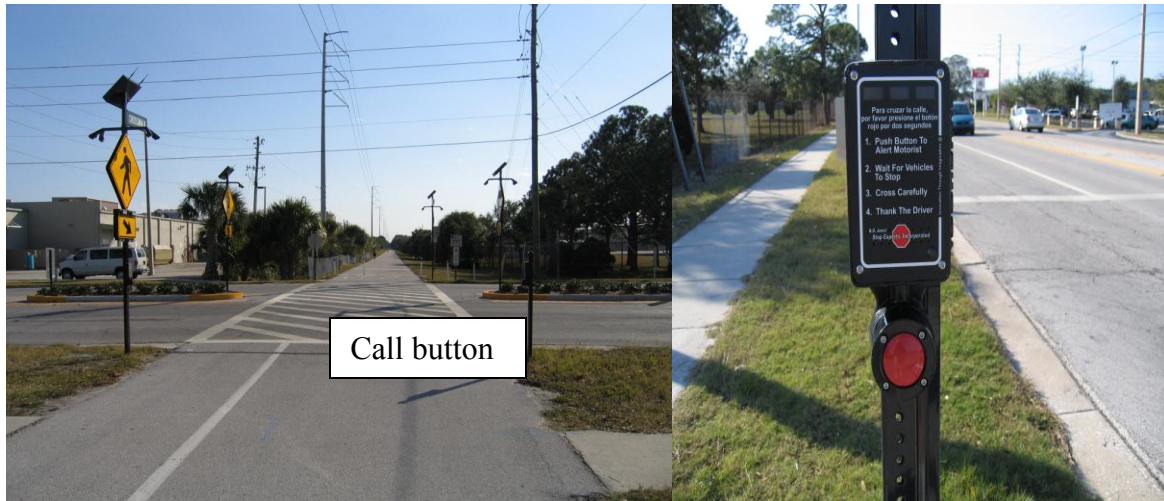
1  
2 **FIGURE 2 RRFB system and close-up view of call button at the Pinellas Trail**  
3 **crossing.**

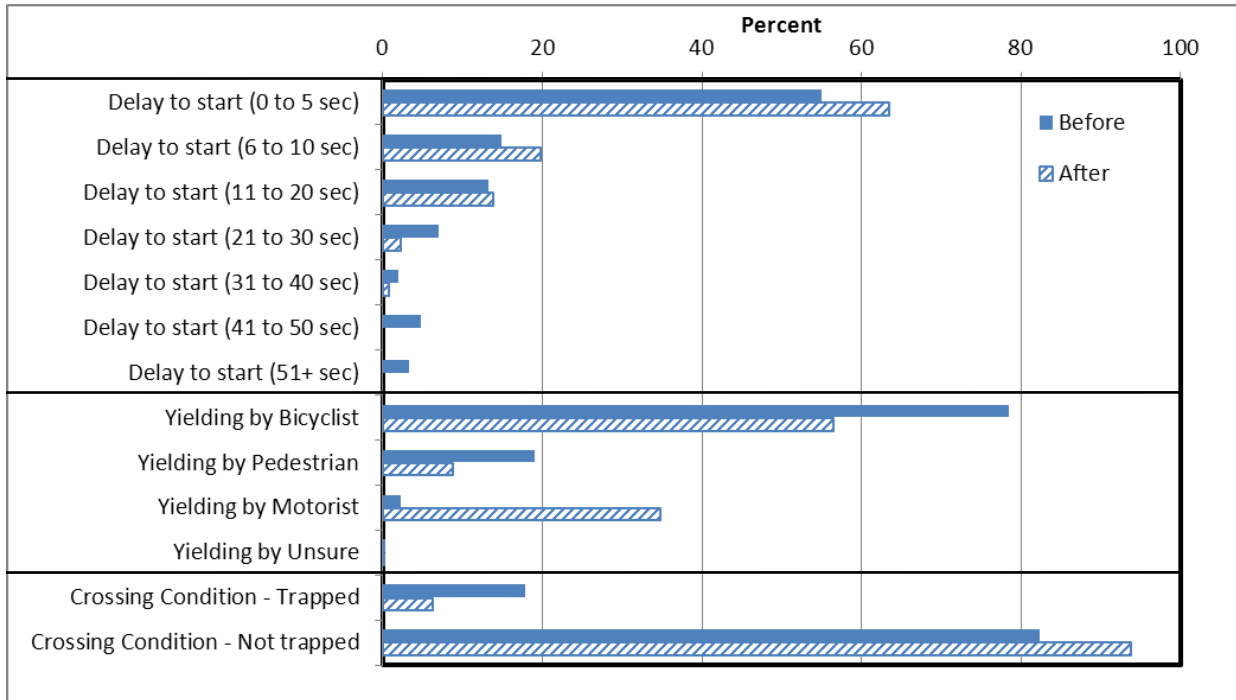
15 The top portion of Figure 3 shows the percentages of delay to start of crossing for trail  
16 users before and after installation of the RRFB. Shorter delays from 0-5 and 6-10 seconds  
17 increased from before to after, while longer delays were more frequent in the before  
18 period. The differences were statistically significant ( $p < .0001$ ). The longest delay  
19 recorded was 89 seconds in the before period. In the after period, there were no delays  
20 more than 40 seconds, and these occurred because the trail user chose not to push the  
21 button to activate the flashers.

25 The middle portion of Figure 3 shows the percentages of bicyclists, pedestrians, and  
26 motorists yielding in the before and after periods while interacting with each other. Only  
27 those situations where the motorist, bicyclist, or pedestrian yielded were considered for  
28 this analysis. The table includes counts of up to four interactions between a bicyclist and  
29 pedestrian with a motorist.

40 The bottom portion of Figure 3 shows the number of occasions when pedestrians or  
41 bicyclists were trapped in the middle of the crossing before and after the implementation  
42 of the RRFB. In the before period, 82 percent of the trail users were able to cross all the  
43 way across the intersection while 18 percent were trapped in the middle. In the after  
44 period, 94 percent of the trail users were able to cross all the way across the intersection  
45 while 6 percent were trapped in the middle. These differences were statistically  
46 significant ( $p < .0001$ ).

**FIGURE 3 Before and after comparisons of delay to start, yielding, and crossing condition.**

31 Bicyclists yielded in 78 percent of the interactions in the before period and 56 percent in  
32 the after period. Pedestrians yielded in 19 percent of the interactions in the before period  
33 and 9 percent in the after period. Motorists yielded in 2 percent of the interactions in the  
34 before period and 35 percent in the after period. Thus, bicyclists and pedestrians yielded  
35 considerably less, and motorists considerably more, after the installation of the RRFB. A  
36 chi square test revealed the differences to be statistically significant ( $p < .0001$ ).

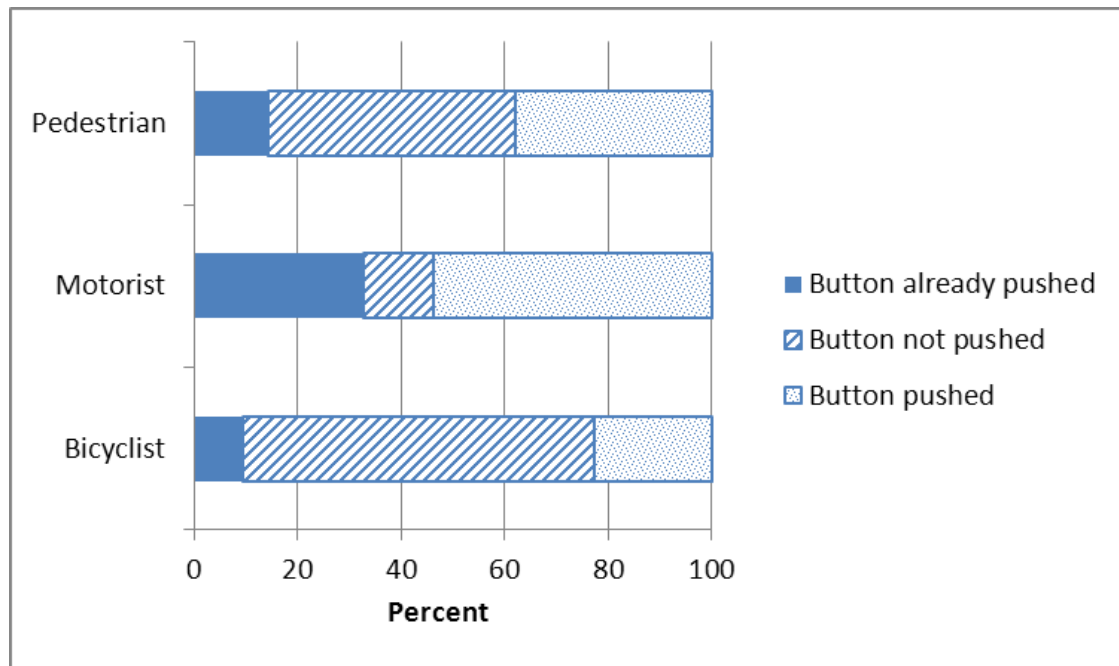
Figure 4 shows the yielding behavior by user group in the after period depending on whether the button was pushed, had already been pushed, or was not pushed to activate the beacon. This table takes into account all the interactions (up to four) between motorists and each trail user. Sometimes a motorist would not yield to the trail user when the button was pushed because of their traveling speed. A subsequent motorist might yield. When a bicyclist yielded, the call button had *not* been pushed in 68 percent of the interactions. When a pedestrian yielded, the call button had *not* been pushed in 48 percent of the interactions. When a motorist yielded, the call button had been pushed in 54 percent of the interactions. The differences were statistically significant ( $p < .0001$ ).

**FIGURE 4 Before and after comparisons of yielding as a function of whether or not the call button was pushed.**

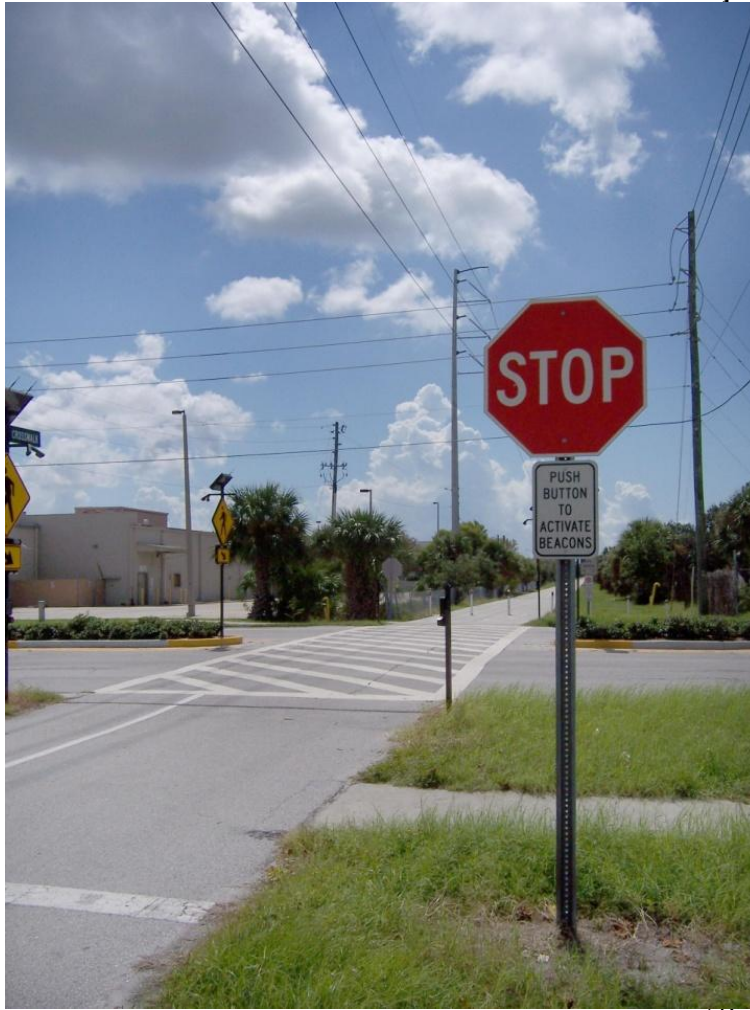
29 **FIGURE 5 Sign to remind users to push the button.**

22  
23 The results pertaining to the trail users being able to cross completely after the  
24 installation of the RRFB are particularly gratifying, as this indicates an improvement in a  
25 safety proxy variable. While motorist yielding improved significantly after installation of  
26 the RRFB, an issue from the findings is why the motorist yielding was not greater. One  
27 factor is whether the button was pushed to activate the flashers. Based on the video  
28 analysis in the after period, it is interesting to note that 32 percent of the trail users  
29 pushed the button, 49 percent did not, and for 19 percent of the trail users the button had  
30 already been pushed. Since almost half of trail users were not pushing the button, the city  
31 installed a reminder sign (“PUSH BUTTON TO ACTIVATE BECONS”) to see if this  
32 would help (Figure 5.) However, not pushing the button remained a problem in follow-up
