1 EVALUATING UNMANNED AIRCRAFT SYSTEMS FOR SNOW AVALANCHE
2 MONITORING IN WINTER WEATHER AND IN MOUNTAINOUS TERRAIN
3
4

2 The Norwegian Public Roads Administration (NPRA) completed an evaluation of Unmanned Aircraft
3 Systems' (UAS) ability to operate in winter weather and in mountainous terrain in support of snow
4 avalanche monitoring. Vendors flew nine multi-rotor, rotary-wing, and fixed wing aircraft on four
5 increasingly difficult missions ranging from flights over a nearby road and bridge to a 2.3 kilometer flight
6 to a 1300 meter mountain to inspect avalanche features. Results indicated that there is no single UAS that
7 meets all of the road administration's needs. The fixed wing aircraft were more capable in bad weather
8 and could fly greater distances to view avalanche release zones. However, they are not always stable
9 camera platforms and required more skill to operate. Multi-rotors were easier to operate and more stable
10 but are less capable in winds and had more limitations when flying to distant features. In general, the

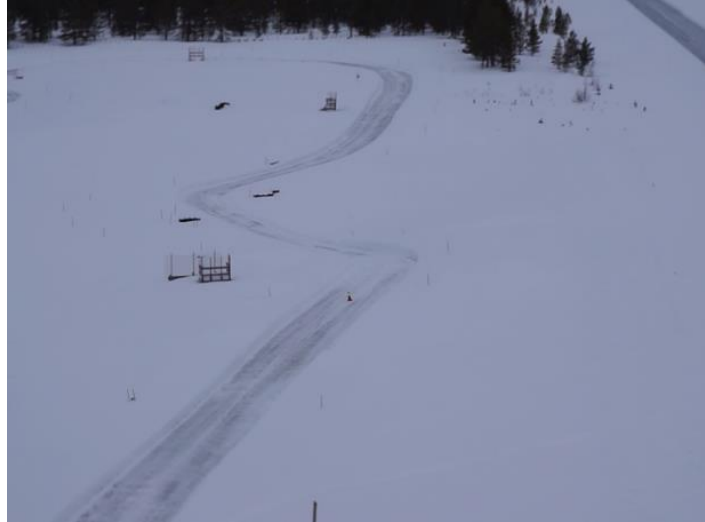
1 in the aircraft and operating by manual control. Another vendor used a GPS to first map the course and
2 then had the aircraft autonomously follow the course. This mission highlighted several vendors' ability to
3 effectively survey and map a road or site. One vendor also had after-flight documentation that showed
4 the coordinates of the six cones. Figure 1 show a UAS's camera view of the course and of a traffic cone
5 on the course.

6
7
8 **FIGURE 1 UAS view of the motocross course.**
9

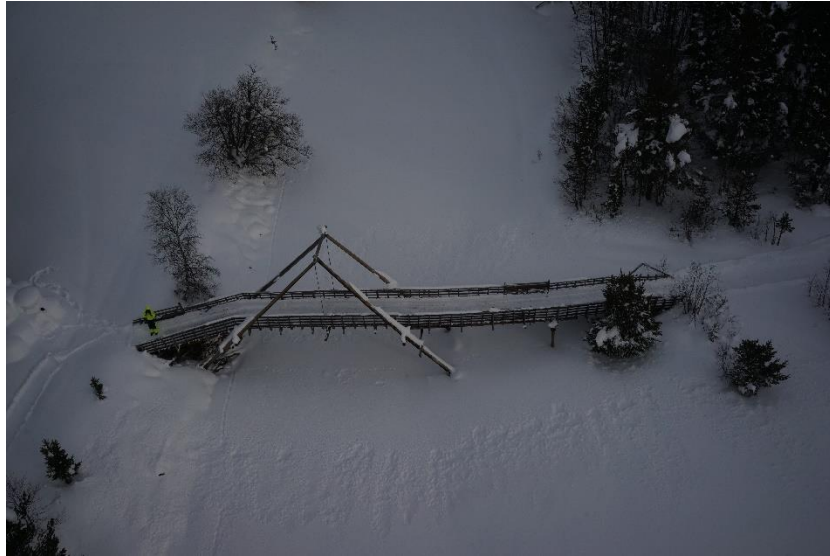
FIGURE 2 Bridge image from UAS

16 This scenario, using a small bridge near the airport, was designed to replicate the inspection of fixed
17 facilities at a known locations that might be difficult to access. All the vendors participated in this test
18 and there were many high quality photos and infra-red views of the bridge. Examples are seen in figures
19 2 and 3. None of the vendors were willing to fly under the bridge. Of note, one vendor used first person
20 view goggles which suggested increase versatility in examining a UAS's camera view in real time.
21

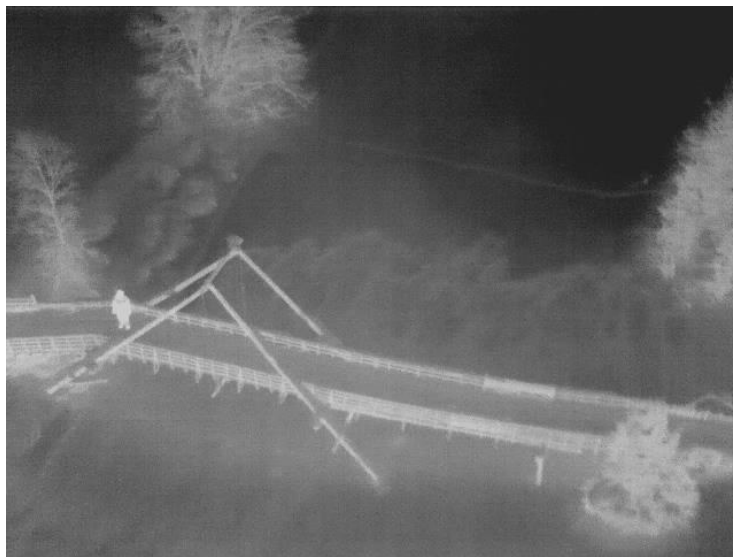
FIGURE 3 Infrared-red bridge photo

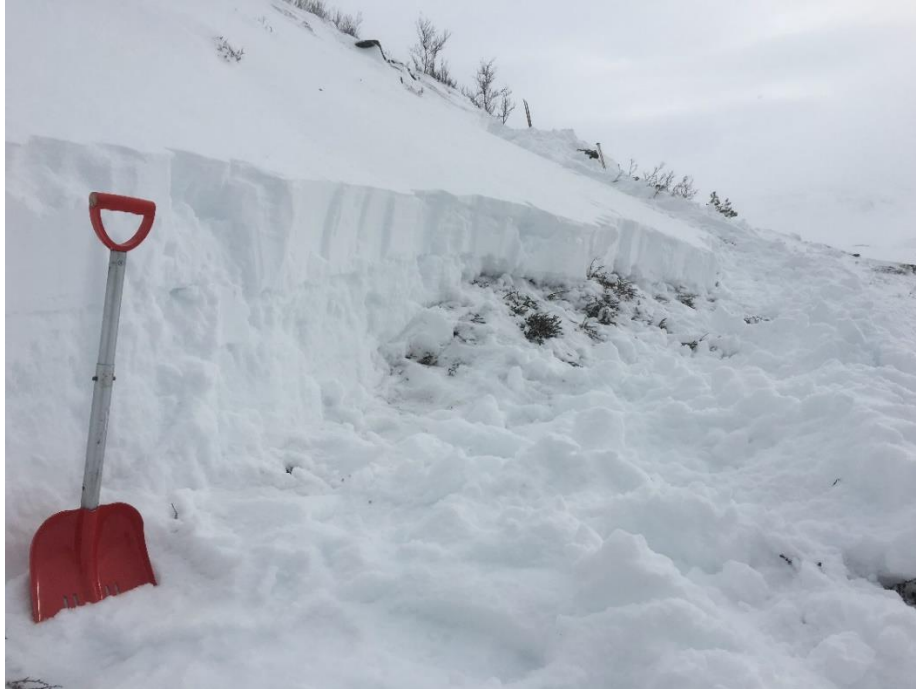
1 and 1 meter deep trench) near the top of Brennhø (Figure 4). A pair of skis and poles were also placed
2 100 meters below the simulated avalanche to replicate the skier accident.

8
9
10 **FIGURE 4 Simulated avalanche on Brennhø**

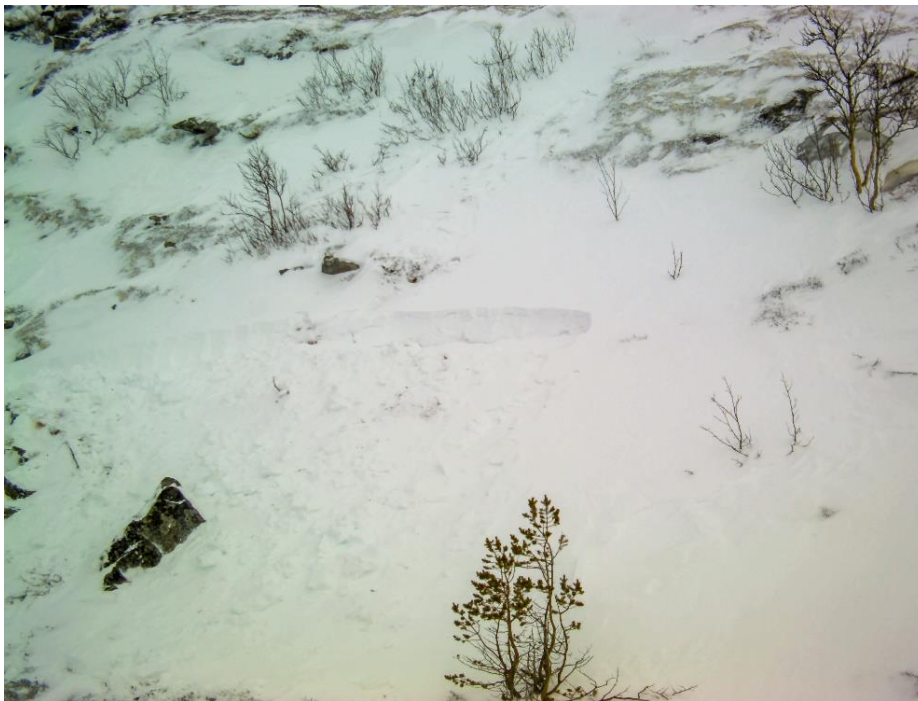
3
4 Two vendors, one with a fixed wing and one with a quad-rotor aircraft completed this scenario. Both
5 UAS produced high quality images of the avalanche and the rotary wing aircraft also located the skis and
6 poles. Figure 5 show UAS images of the simulated avalanche. Figure 6 is an infra-red view of the
7 avalanche which clearly shows the avalanche's wall.

11
12 **FIGURE 5 UAV view of the simulated avalanche**

5 The aircraft are simply a vehicle to carry cameras and sensors to an area of interest. In the demonstration,
6 the photo and video quality general was good and several were exceptional. For example, the simulated
7 avalanche in Mission C was quite easy to see using the camera on small quad-rotor. As an added benefit,
8 this system fit in two small cases, was highly portable, and could be carried by skiers. This suggests in
9 some cases, this use of this UAS and camera could replace the need for NPRA observers to travel into
10 avalanche areas.

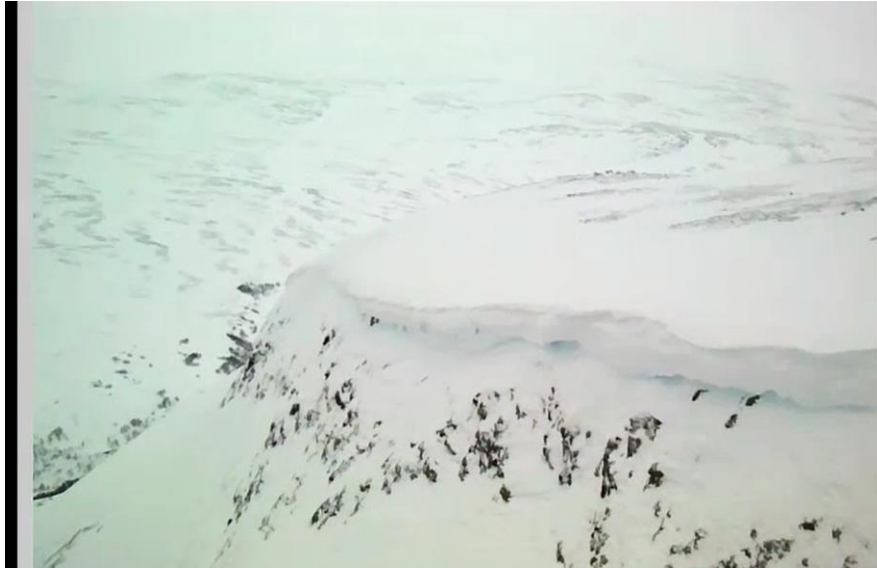
1
2 **FIGURE 7 Screenshot from video showing cornice on of Kvernhusjø**

37
38 *“I viewed the video from the cornice mission ..., I think, in some cases, we can get better*
39 *quality/information from video/pictures than a manned helicopter. This is because the drone can fly*
40 *closer to the mountainside than a manned helicopter. In this case the drone flew only few meters from*
41 *the cornice. Impressive!”*
