SUMMARY OF THE NCHRP REPORT 350  
CRASH TEST RESULTS FOR THE  
CONNECTICUT IMPACT ATTENUATION SYSTEM (CIAS)

December 2004

2216-3-03-6

Connecticut Department of Transportation  
Bureau of Engineering and Highway Operations  
Office of Research and Materials

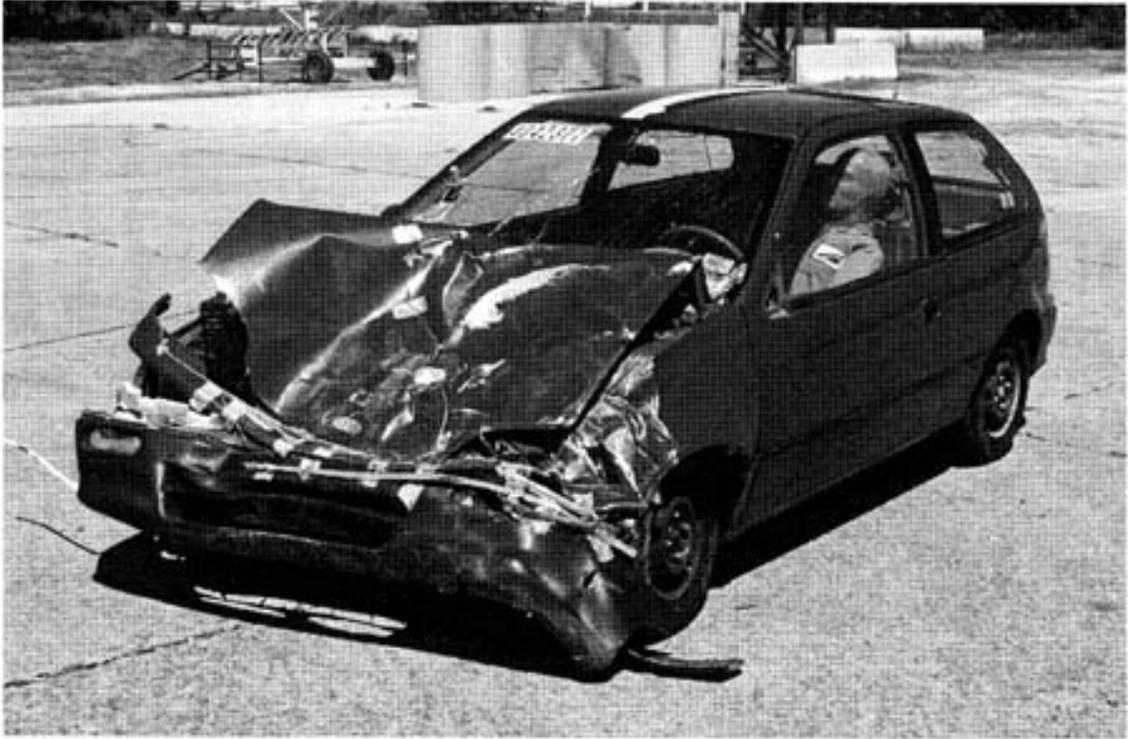
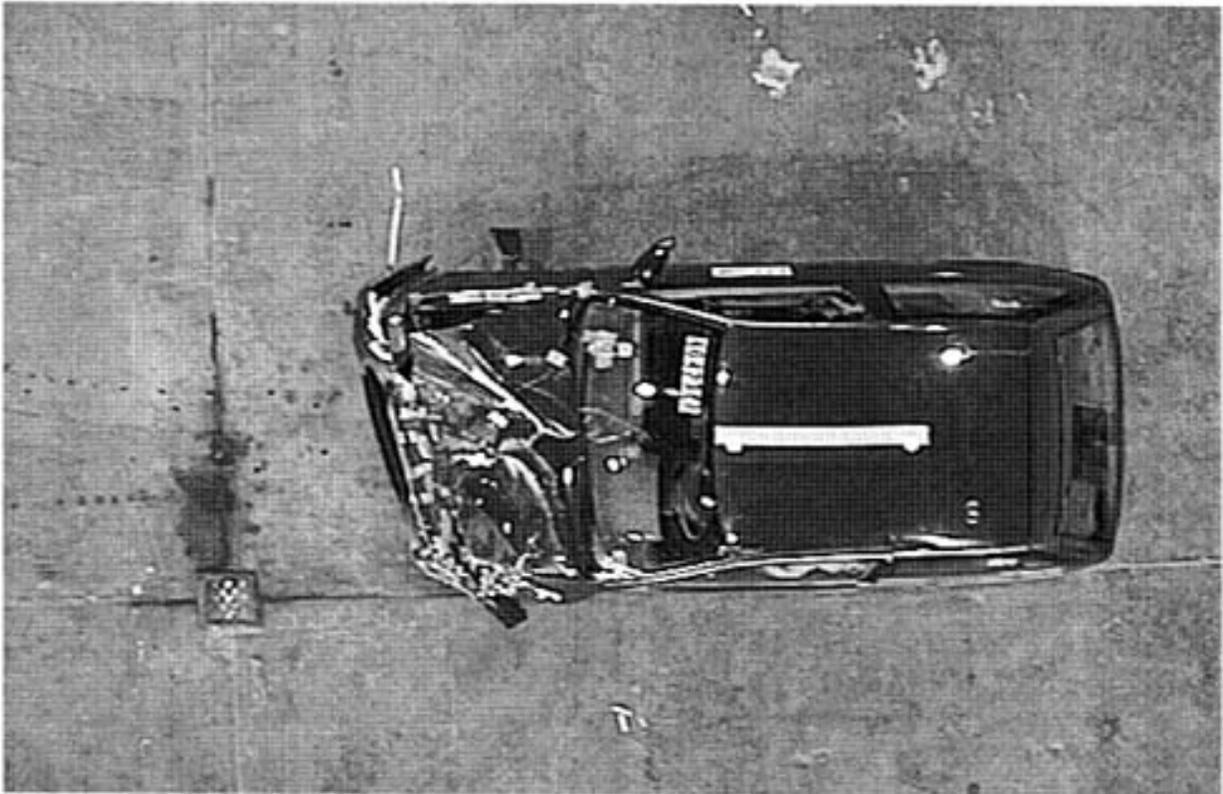
Figure B3-6 Vehicle After Test 3-34

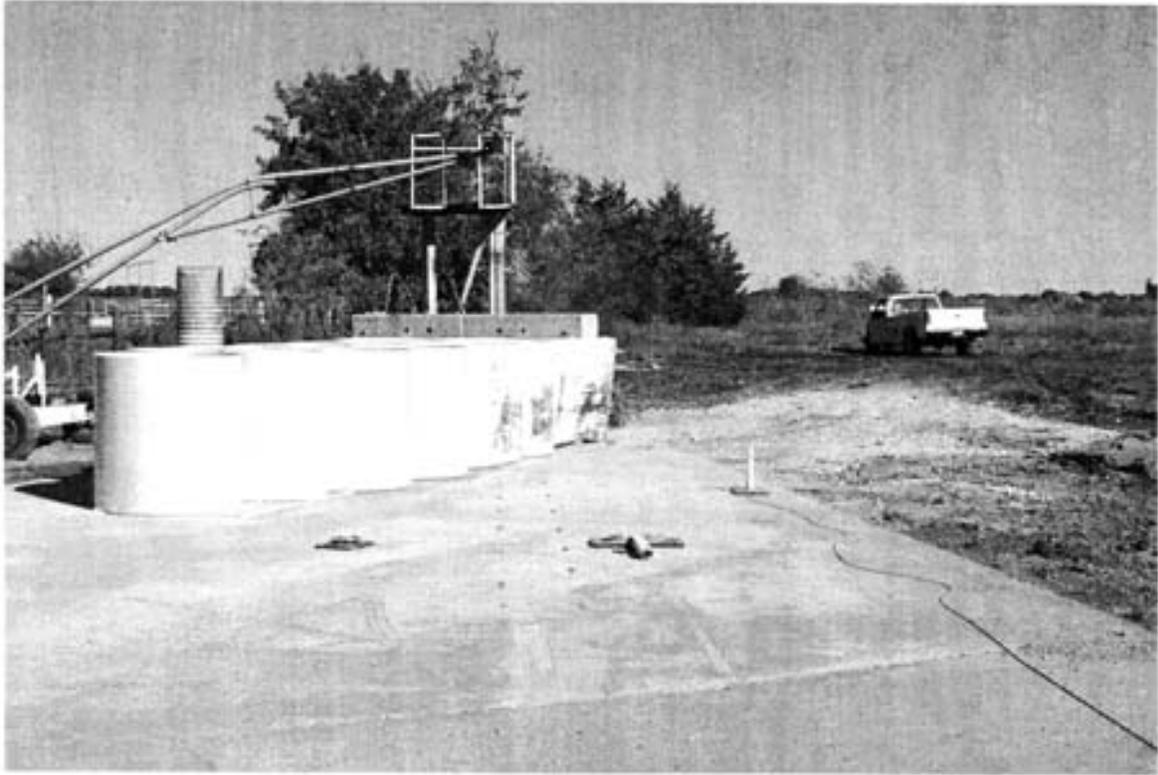
Figure B4-4 Installation After Test 3-35

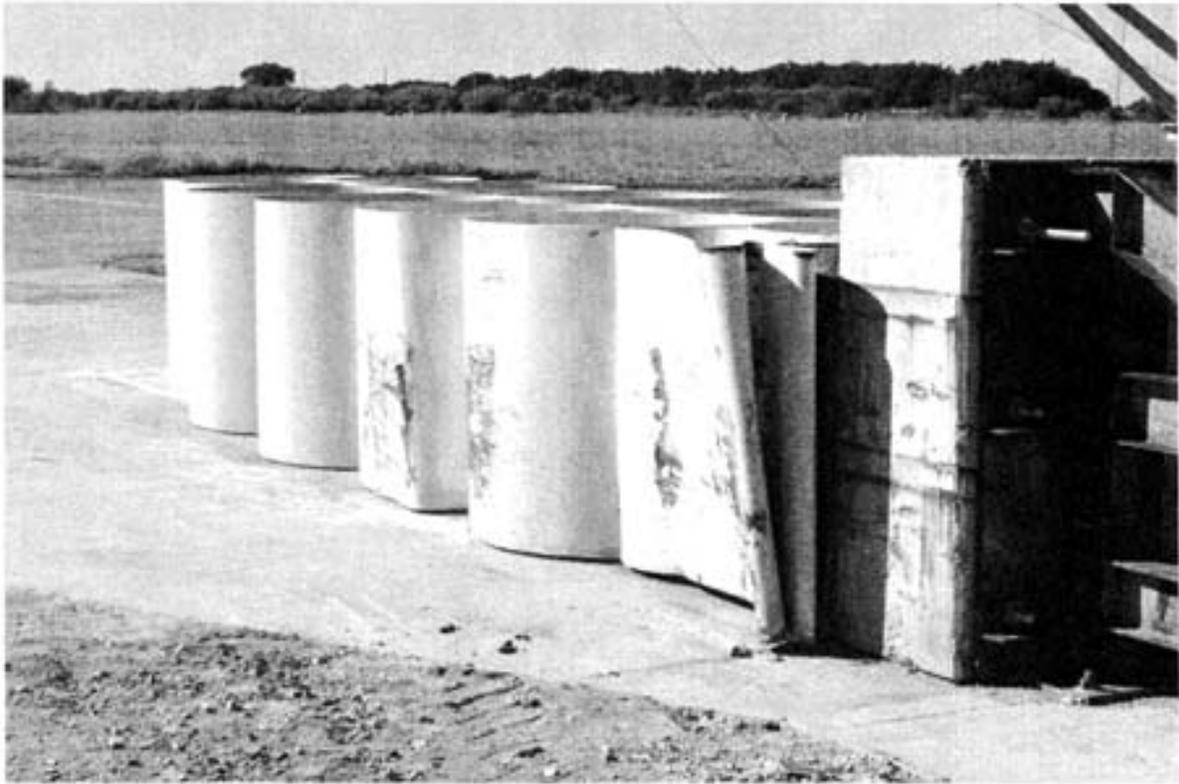
Figure B4-5 Installation After Test 3-35 continued

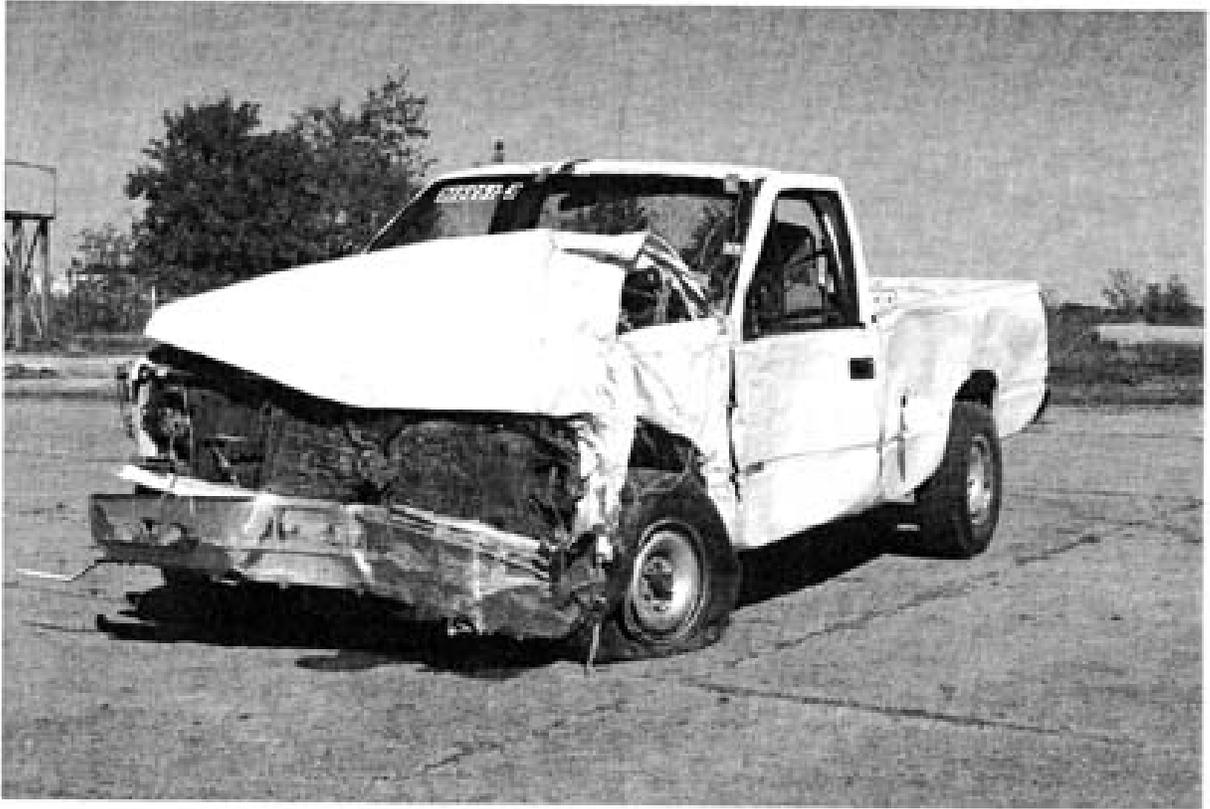
Figure B4-6 Vehicle After Test 3-35
